# NASA Engineering and Safety Center (NESC) Consultation on Cracking in Shuttle Orbiter's Reaction Control System (RCS) Thrusters

Dr. Rebecca MacKay  
Materials and Structures Division  
September 8, 2006

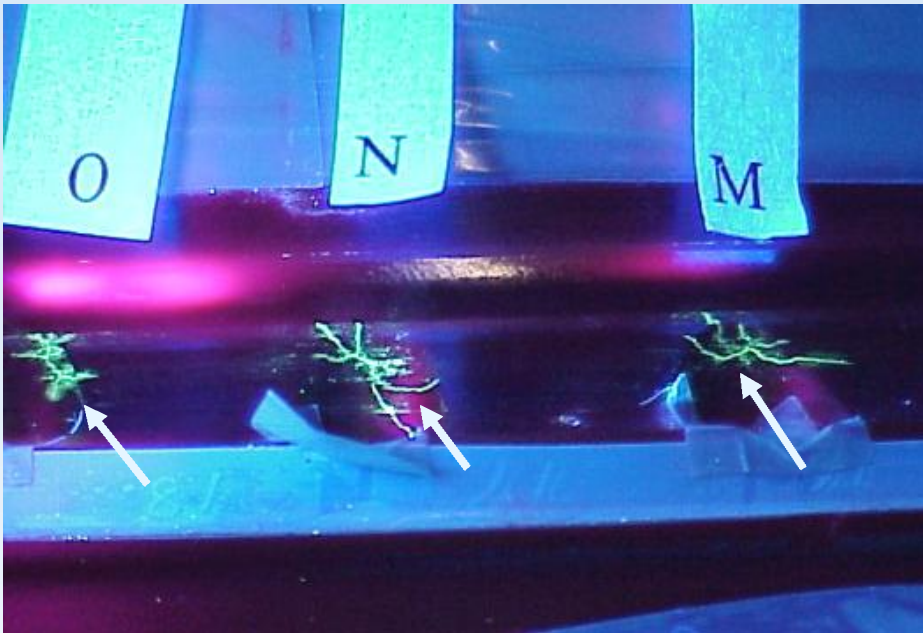
Counterbore cracks

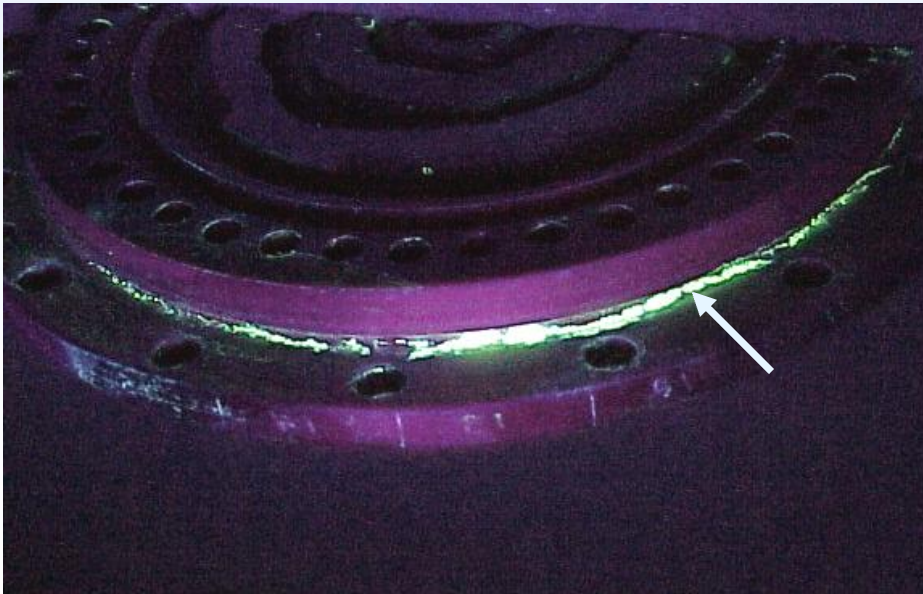
Relief radius cracks

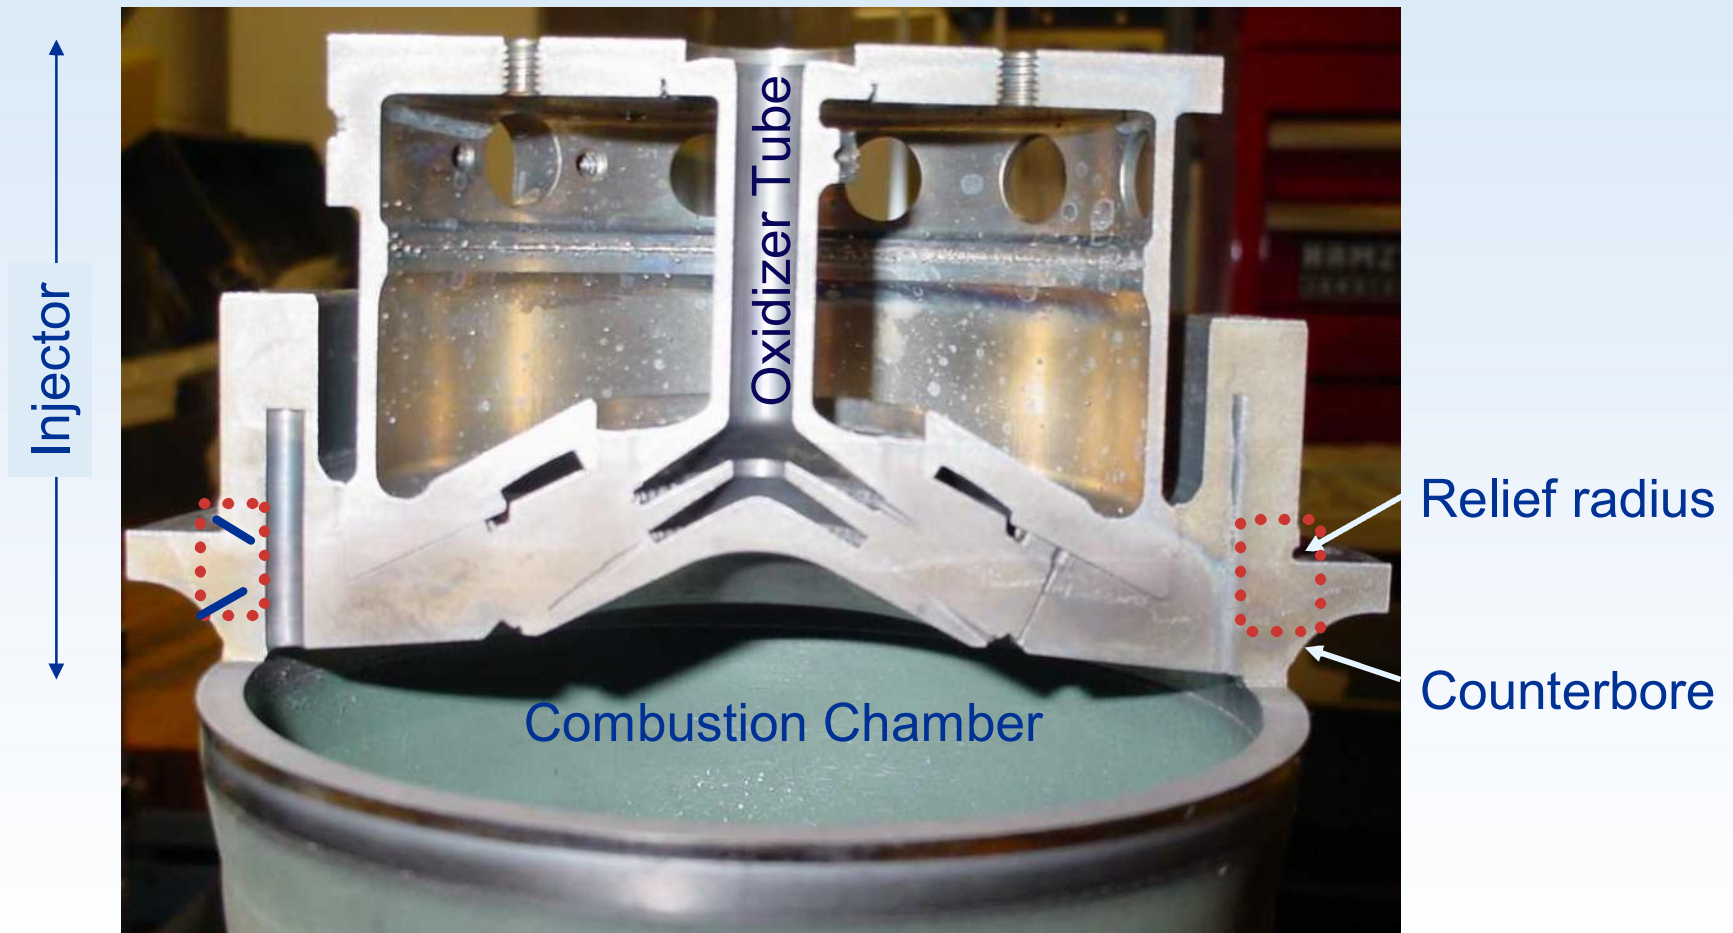
*Location of Cracking is Shown in Red Boxes*

*Concern was that hot combustion gases may leak through the cracks and adversely affect the orbiter vehicle*

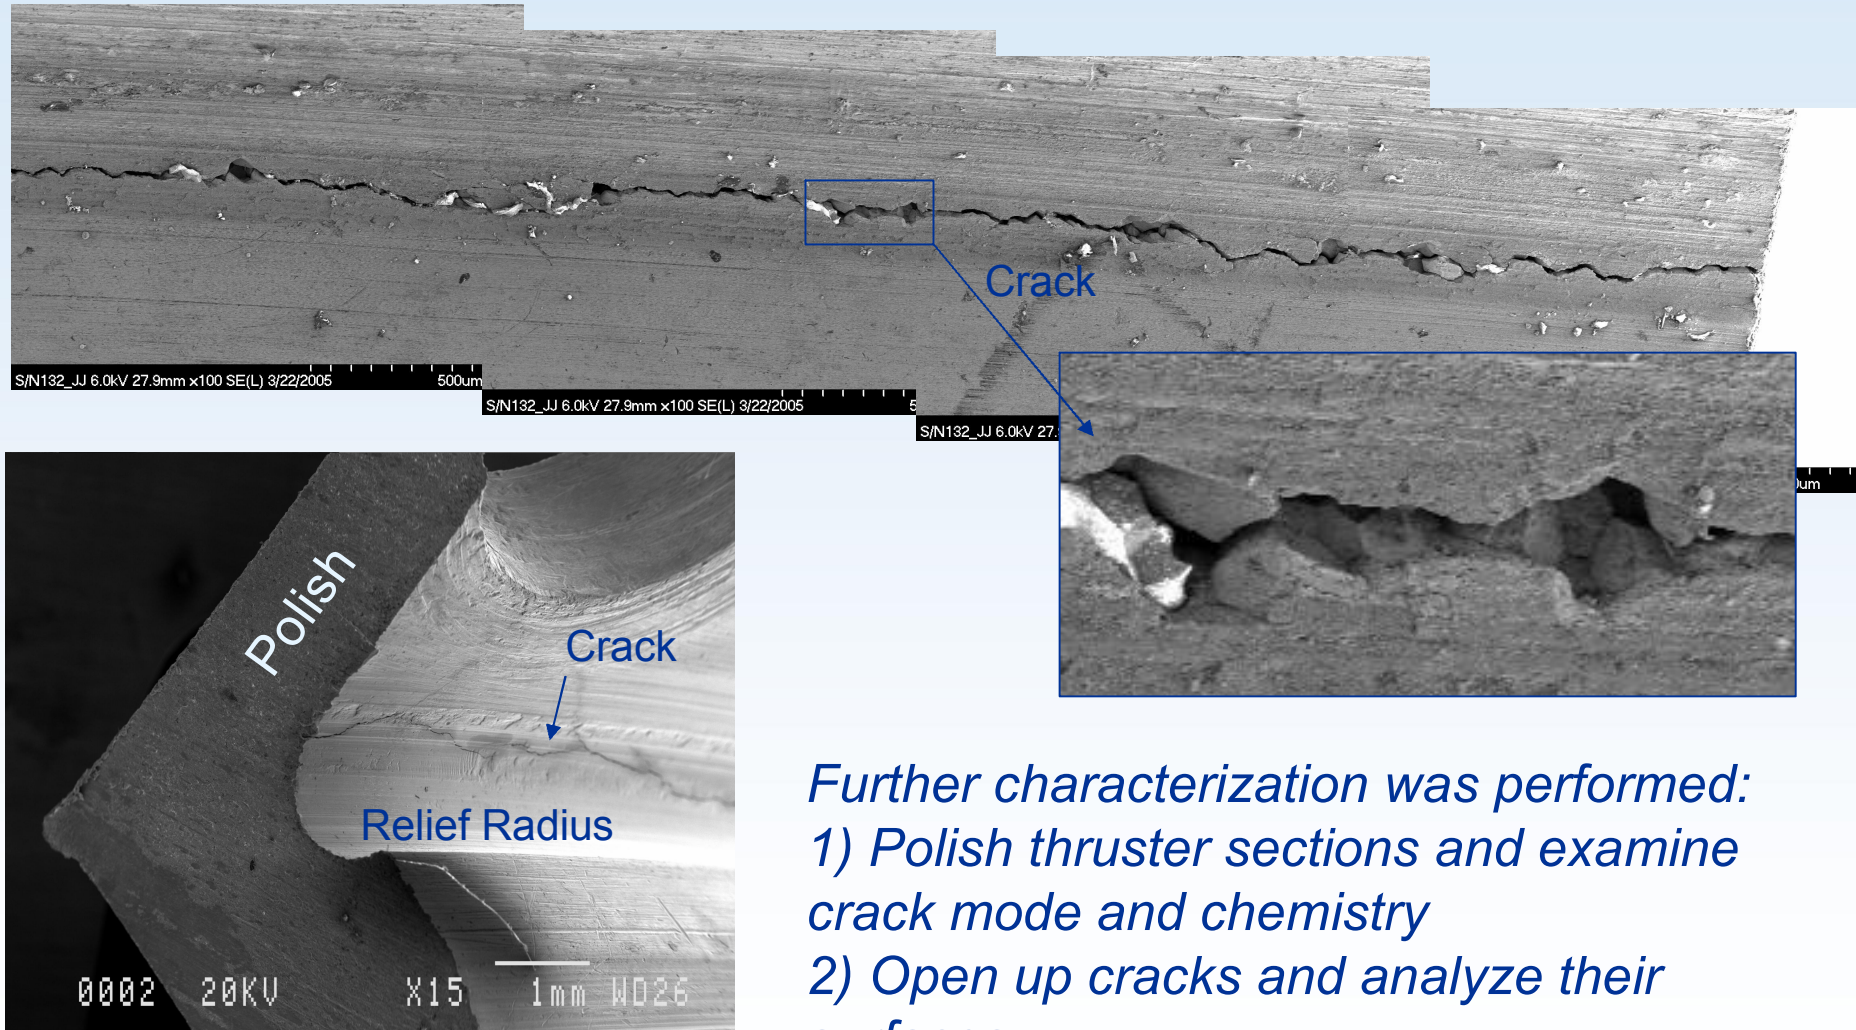
# Cracks on the Surface of the Thruster Hardware Appeared to Follow Grain Boundaries

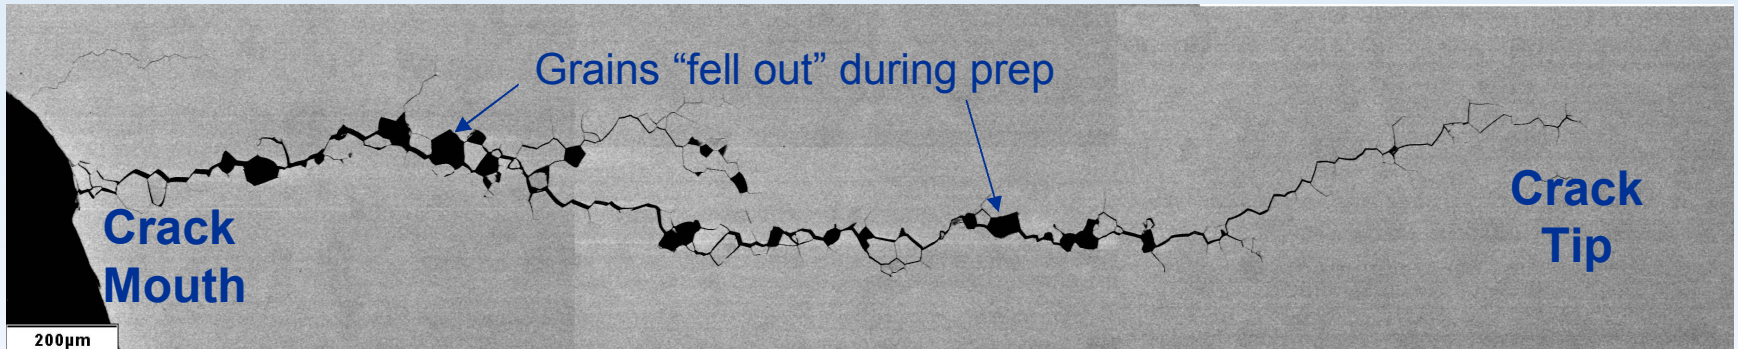
# Detailed Microstructural Analyses Were Performed at Crack Mouth and Crack Tips

## *Cracks are Intergranular and Follow the Grain Boundaries*

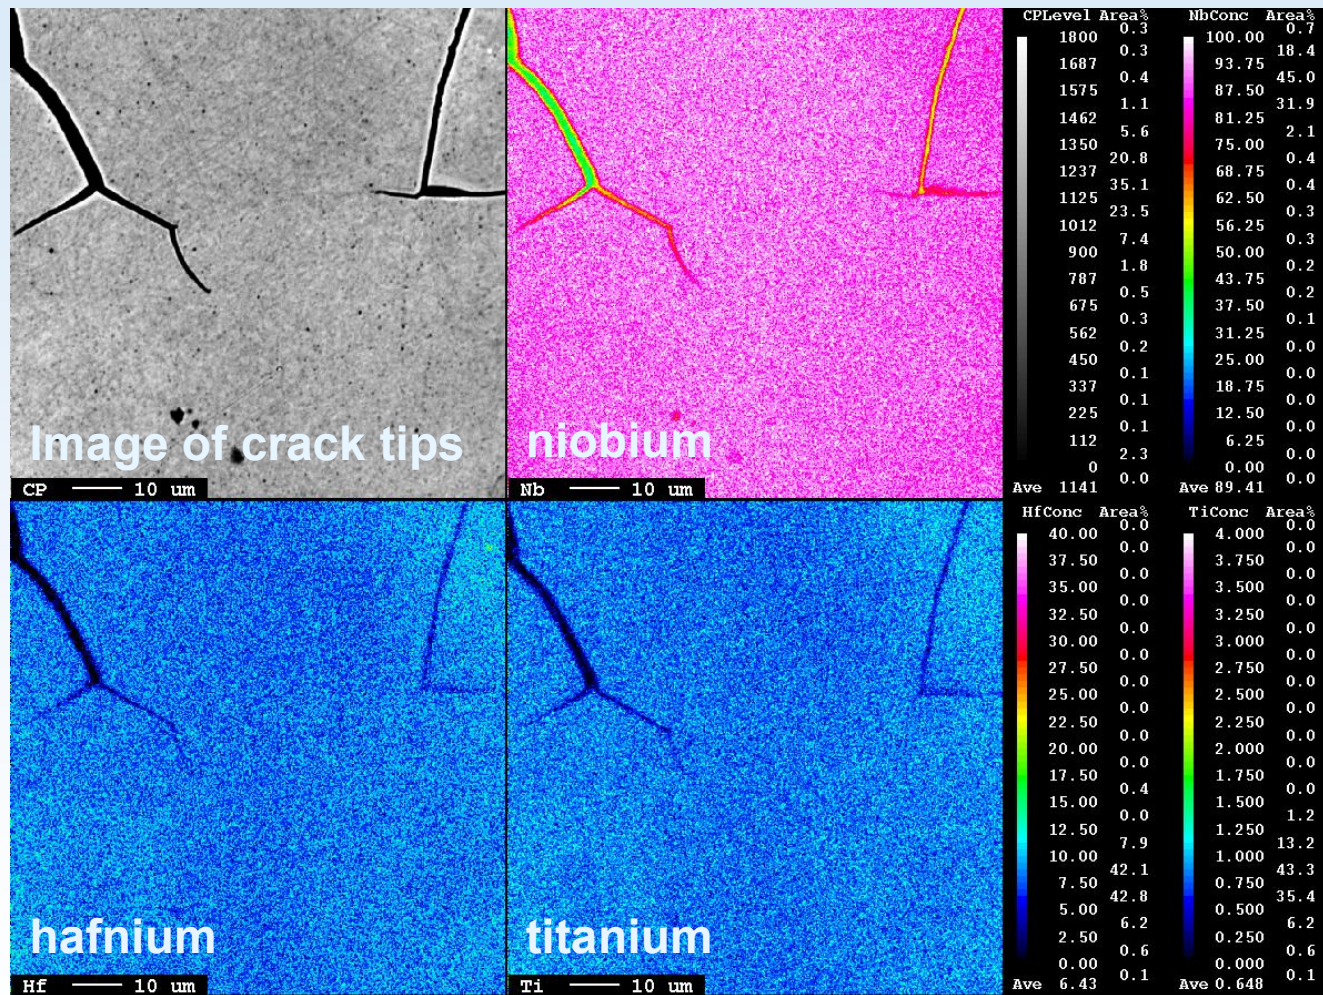
# Electron Microprobe Indicated that the Major Elements Did Not Segregate Along the Grain Boundaries

***Eliminated Hot Salt Stress Corrosion as a Potential Root Cause***

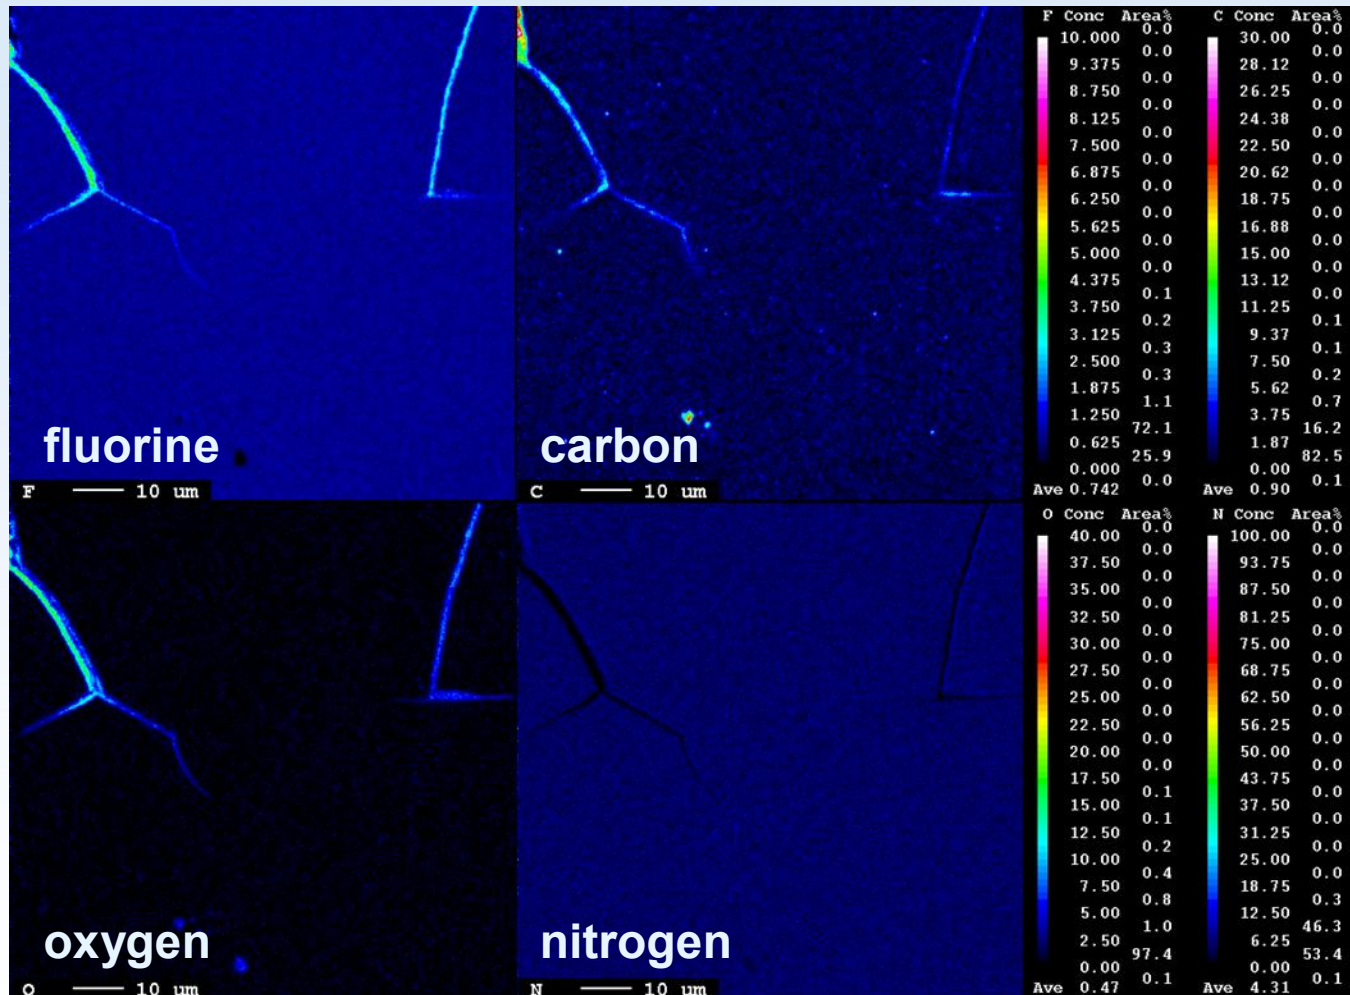
# Chemistry Within Cracks Is Consistent with Reaction Products from Manufacturing

Fluorine came from pre-weld etchant. Carbon and oxygen were introduced during bake out after welding. No interstitial contamination ahead of cracks. Next step involved examination of broad expanses of crack surface.

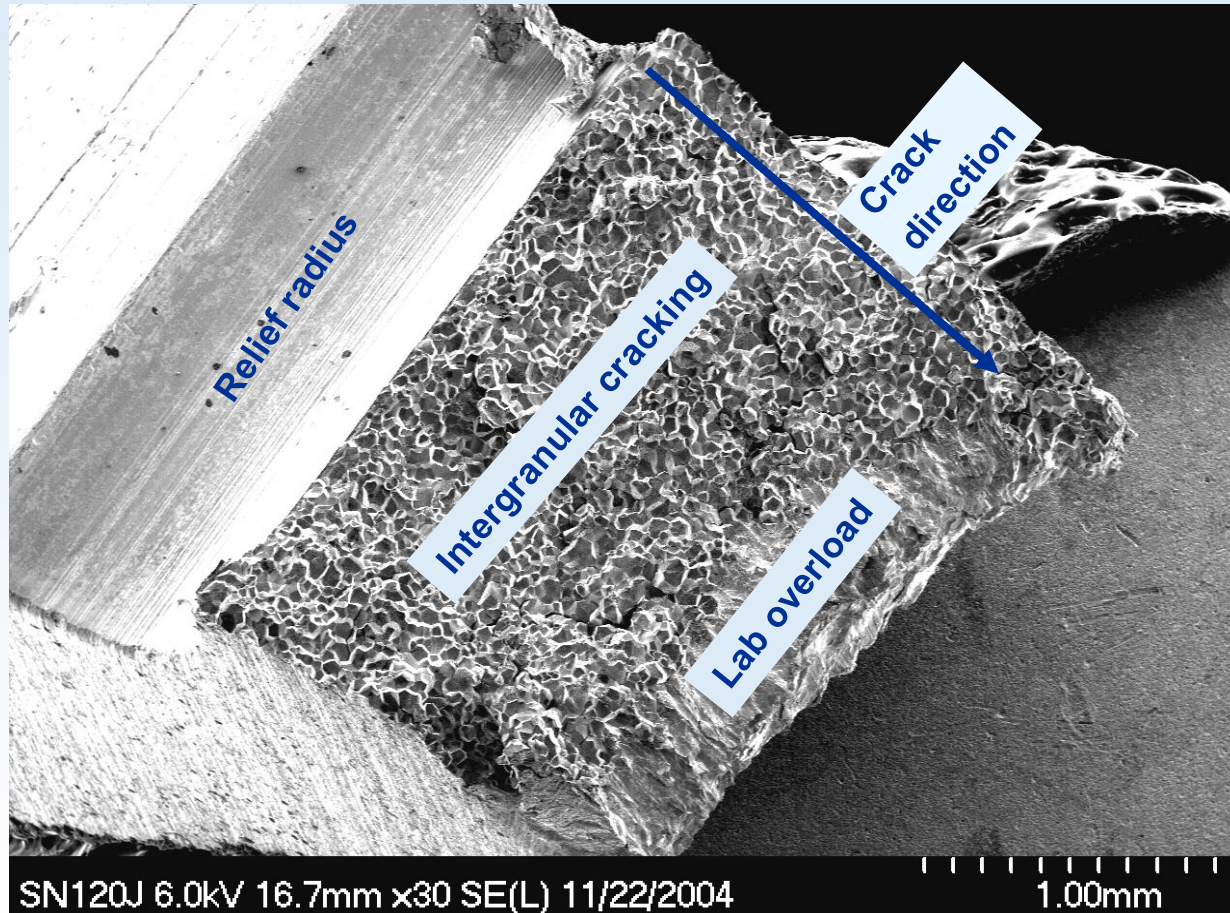
# Entire Fracture Surface of Crack Was Intergranular

## *No change in crack mode*

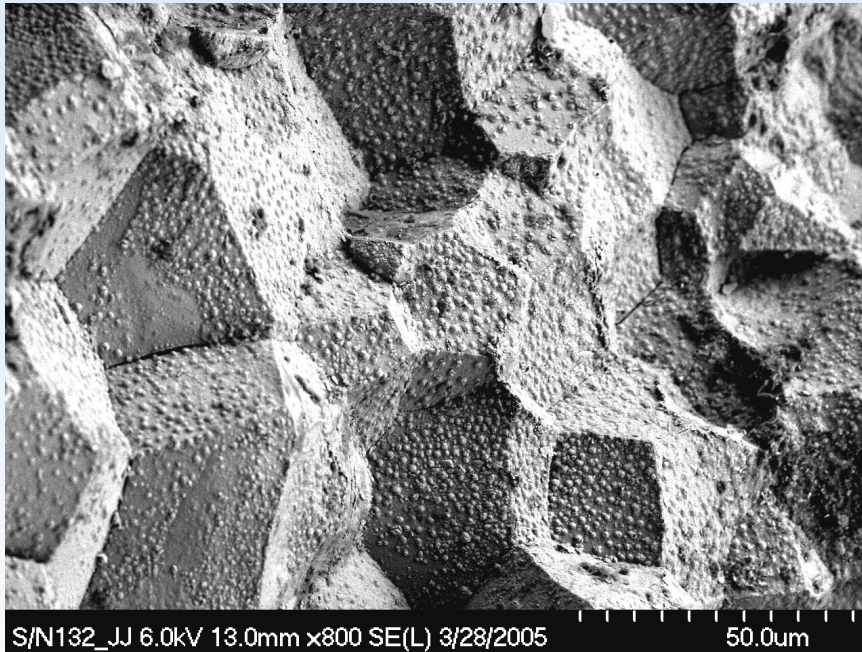
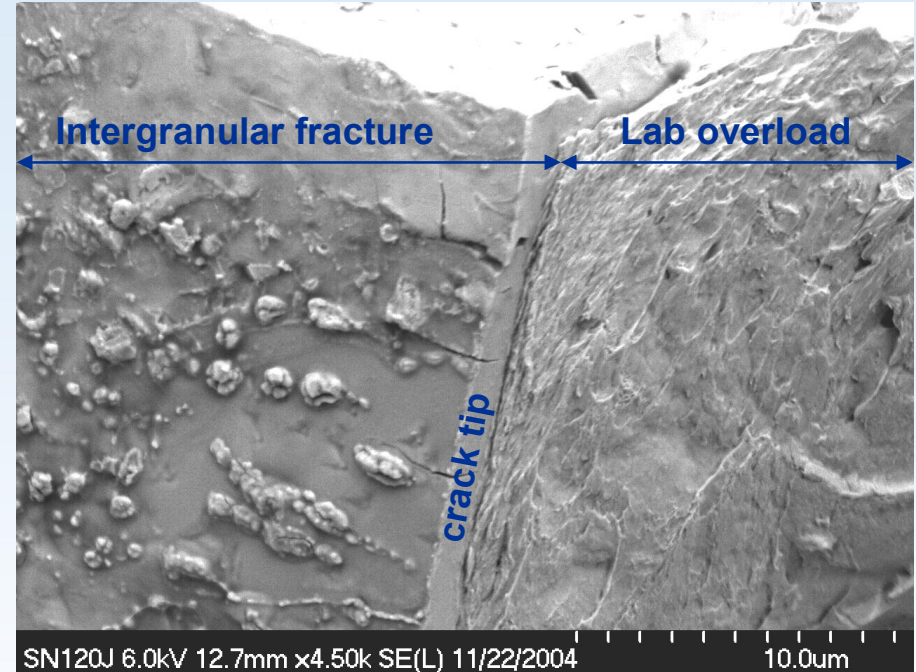
# Exhaustive Quantitative Analyses on Thruster Cracks Provided No Evidence for Crack Growth in Service

- *No significant changes were observed in crack features or reaction products from crack mouth to crack tip*
- *State of the oxide did not change over the crack depth, which suggests that the crack did not grow slowly over time in service*
- *Lab tests demonstrated that popcorn oxide forms on niobium during manufacturing bake out in air when cleaning etchants are present*

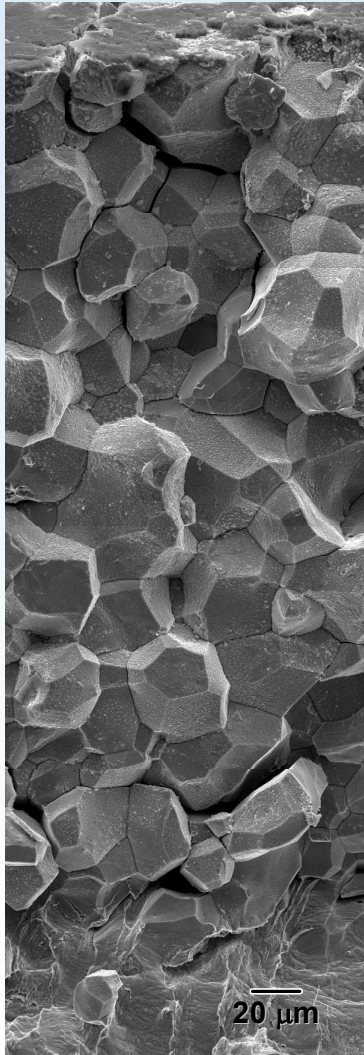
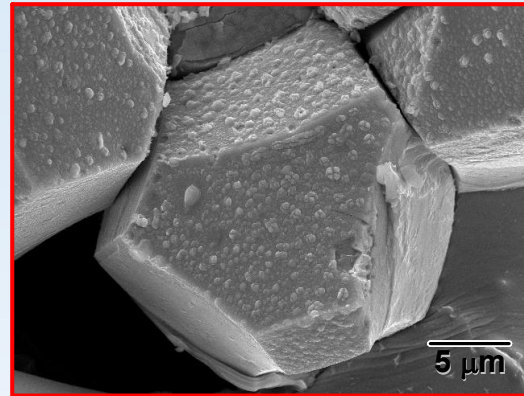
# Simulation of Thruster Processing on Test Specimens Reproduced the Fracture Mode Observed in Thruster Hardware

**Long term testing of a cracked specimen  
in a moist air environment showed no  
evidence of crack growth**

***Demonstrates that water ingress into  
existing thruster cracks is unlikely  
to cause further crack growth***

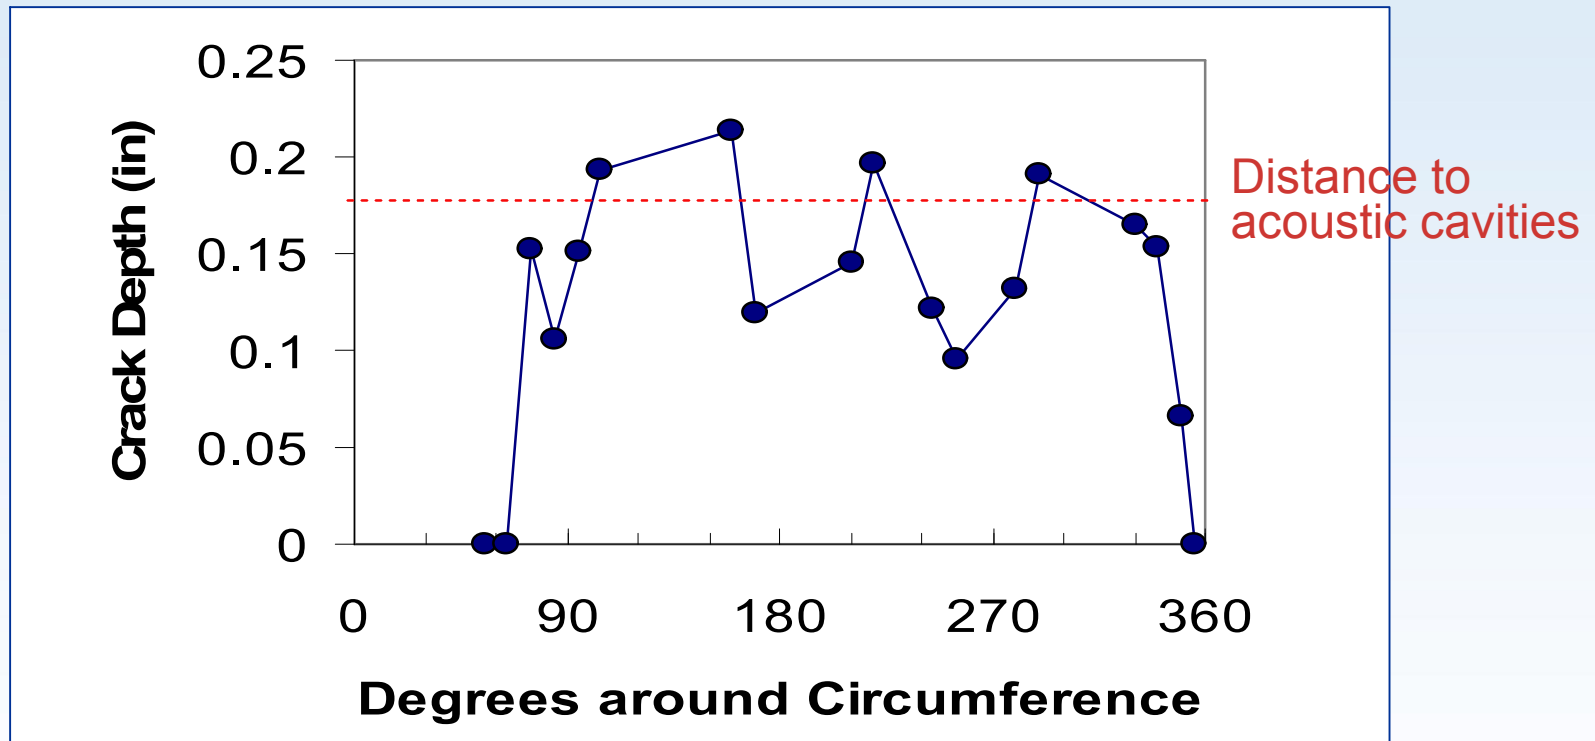
# NESC Destructive Analyses Indicated Significant Relief Radius Cracking in S/N 132

*Crack depth profiles were provided to Boeing for fracture analysis which indicated that the thrusters have a remaining life that was well in excess of 8-mission maintenance cycle where helium leak checks are performed.*

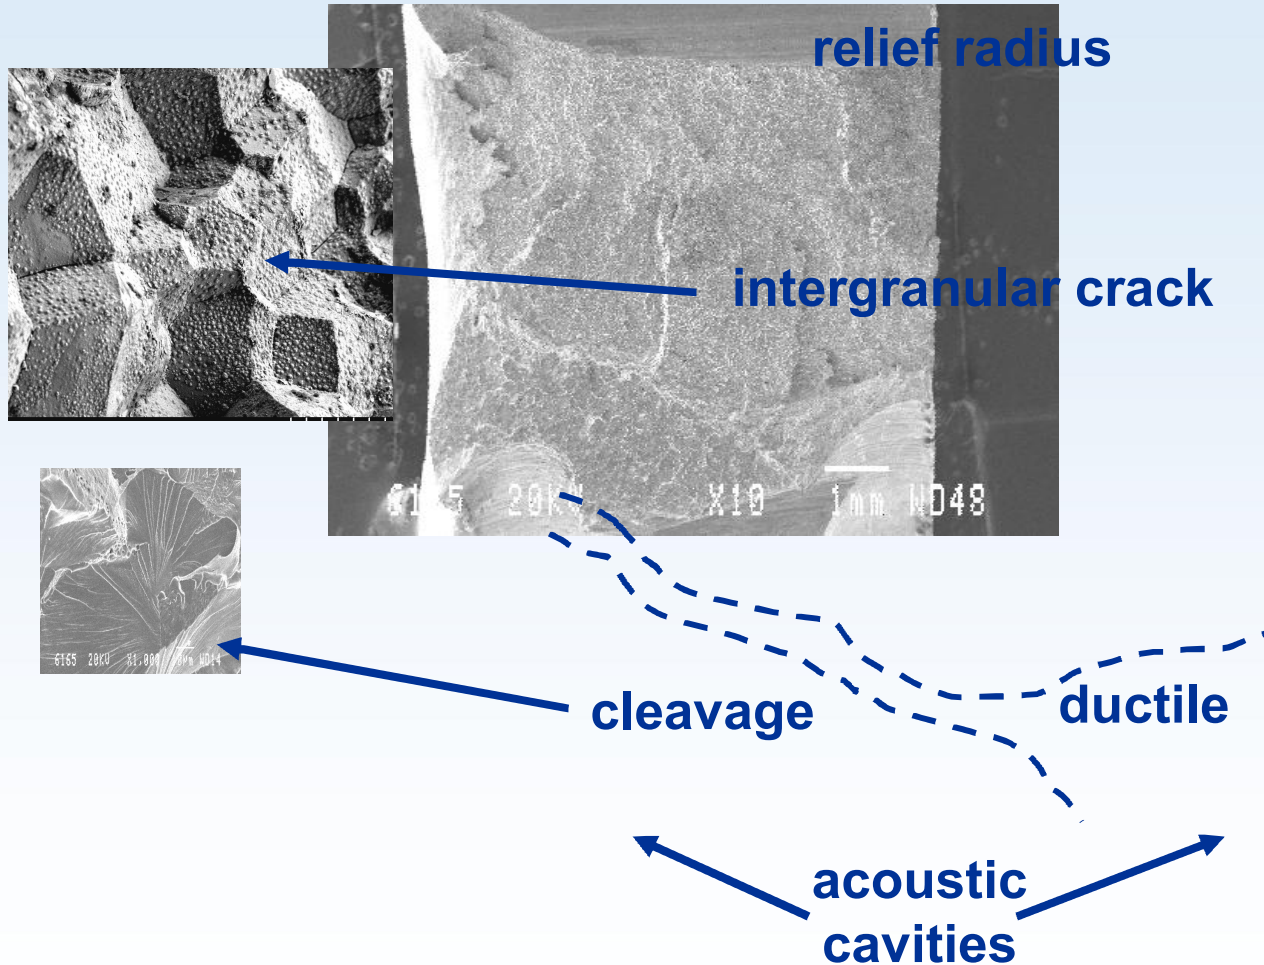
# Boeing Fractography Showed Transgranular Cleavage Ahead of the Relief Radius Crack in S/N 120

***Niobium is normally a ductile material; cleavage was not expected***

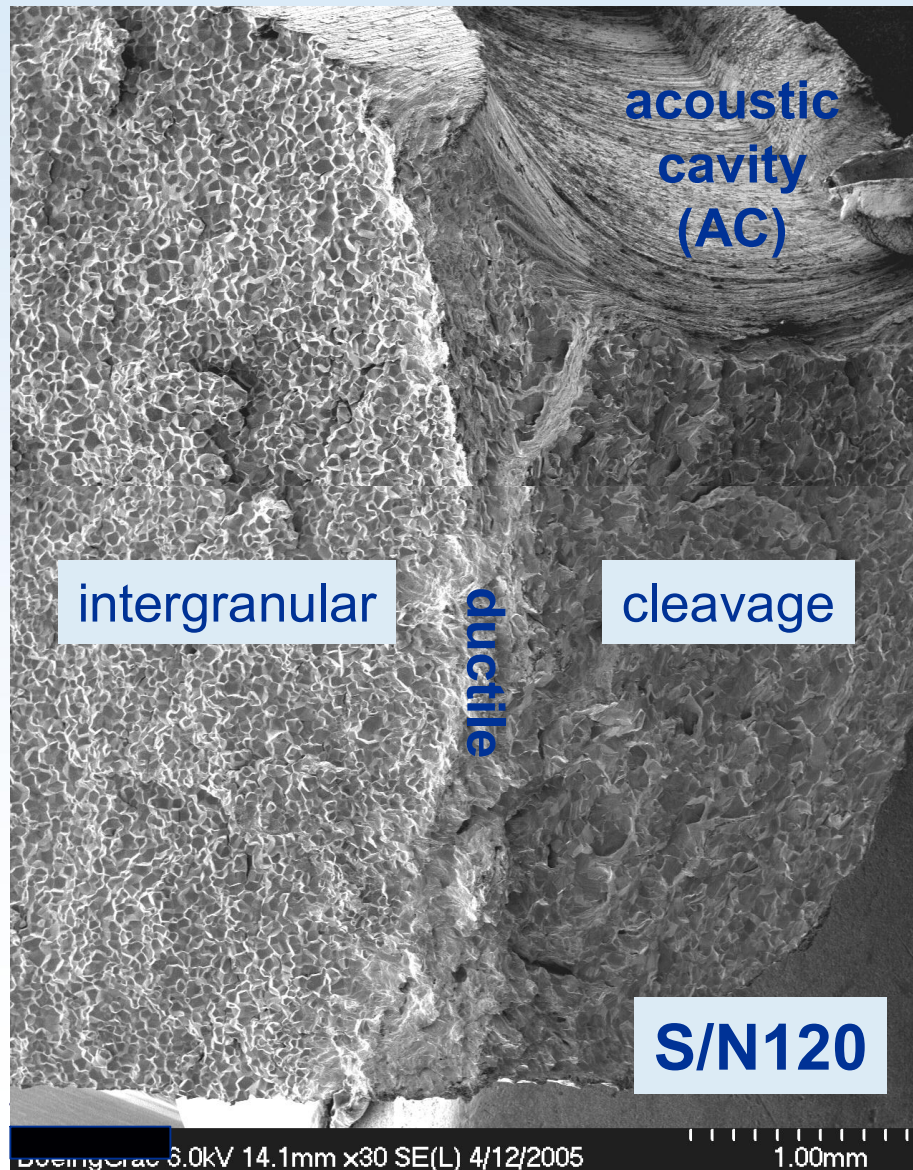
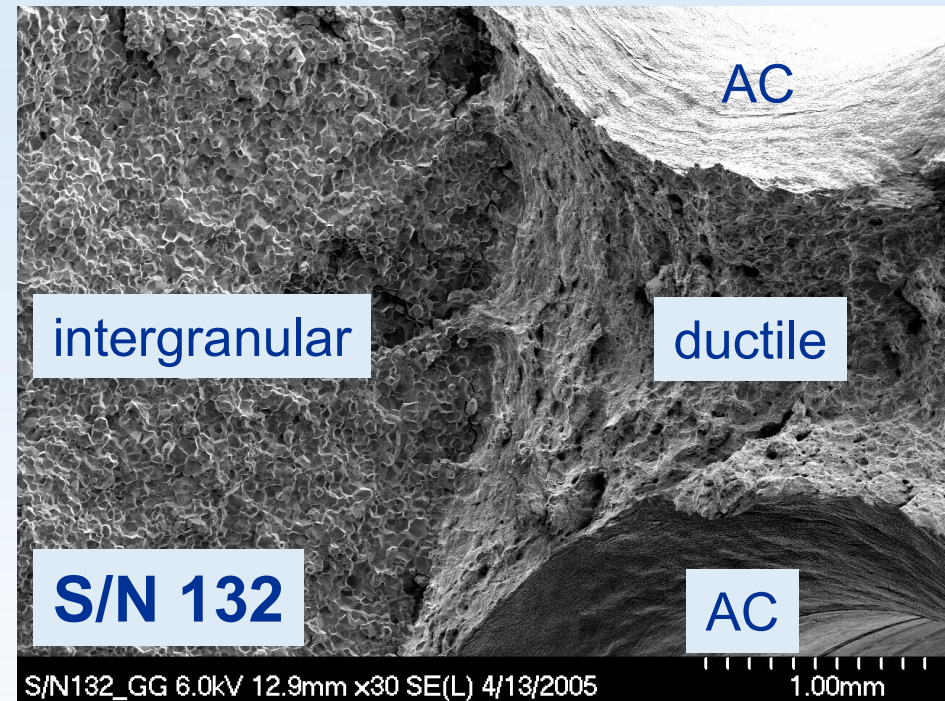
# GRC Fractography Showed Transgranular Cleavage in S/N 120 But Not in S/N 132

- *S/N 120 was a rejuvenated thruster and was immersed in NaOH*
- *S/N 132 was never rejuvenated and was not exposed to NaOH*
